# VACUUM EXPLOSION TRIPLATE

## The State-of-the-Art Transition Joint Technology

Comparative Technical-Scientific Analysis

### SHOCKWAVE METALWORKING TECHNOLOGIES BV

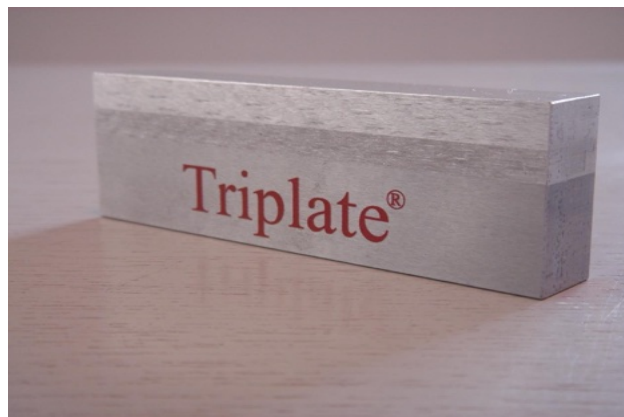
Figure 1. Triplate® transition joint, three-layer composite strip (steel / Al 99.5% / AlMg4.5Mn). The three layers are visible on the end face.

- Steel base layer (Shipbuilding Grade A/D/DH36, or St52-3N): fully compatible with conventional steel welding processes SMAW, GMAW, FCAW.
- Pure aluminium interlayer (Al 99.5%, Alloy 1050A): the critical buffer zone. High ductility absorbs the shock of the bonding process and accommodates differential thermal expansion in service. Because carbon steel expands less thermally than aluminium, a responsible compressive stress builds up in the aluminium when the temperature increases. This is the reason why the strip does not warp.
- Marine aluminium top layer (AlMg4.5Mn, Alloy 5083): seawater-corrosion-resistant alloy, weldable by standard TIG/MIG procedures directly to aluminium superstructures.

Standard strip dimensions: 19, 28, and 34 mm thickness; lengths up to 3,800 mm; widths up to 1,350 mm. Custom profiles available via water-jet cutting. The recommended strip width is four times the aluminium plate thickness ( $4 \times t$ ). The reason for this is that it compensates for the lower mechanical value of the aluminium.

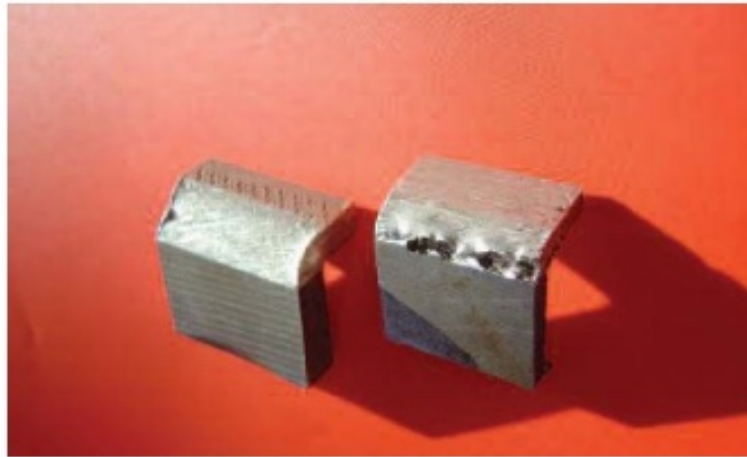
Figure 5. The consequences of the Hammer Bend Test (MIL-J-24445A). Left: vacuum-clad Triplate®: interface intact, no defect formation. Right: open-air cladding: oxide conglomerates open out visibly at the turbulent transition layer.  
Source: Buijs, N.W. (2010). Explosive Welding of Metals in a Vacuum Environment. Stainless Steel World, March 2010.  
(Photo: Innomet b.v.)

**Hammer Bend Test: visual demonstration of trapped oxide consequences:** The consequences of turbulence-trapped oxides can be directly demonstrated by the Hammer Bend Test (MIL-J-24445A). A narrow clad strip is clamped at the bonding interface in a bench vice and the protruding part is bent 90° with a hammer. In open-air clad joints, the oxide conglomerates trapped in the turbulent transition layer open out visibly during this test, confirming the presence of interface defects that no post-production inspection can eliminate. In vacuum-clad Triplate® joints, the clean laminar or mildly wavy interface withstands the test without any visible defect formation.

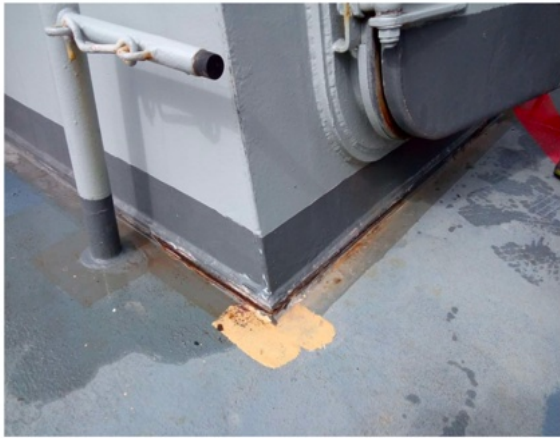
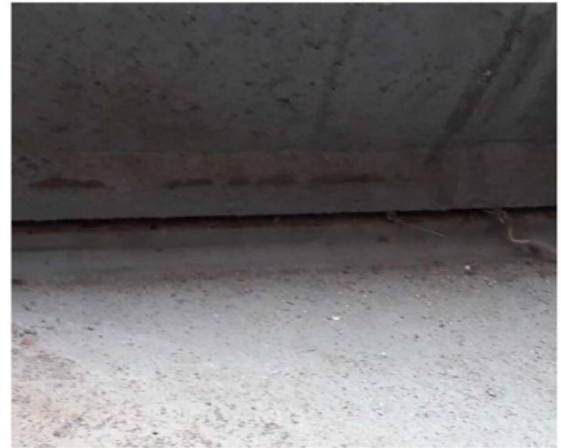
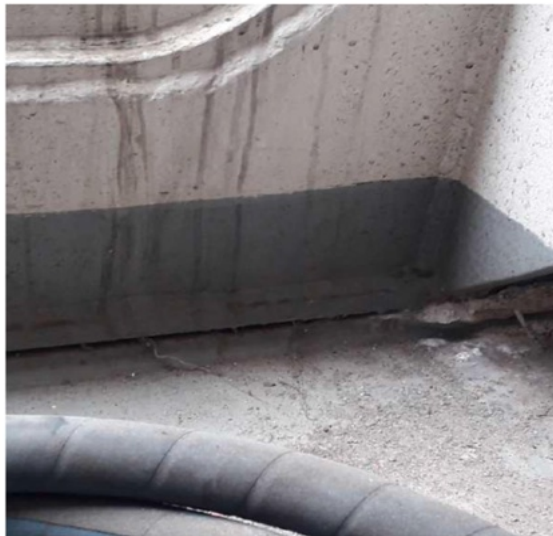
Figure 6. Crack in the port-side (Br) heat shield of the Meteoro

Figure 7. Crack in the port-side (Br) heat shield of the Meteoro

Figure 8. Crack in the port-side (Br) heat shield of the Meteoro

Figure 10. Crack in the port-side (Br) heat shield of the Meteoro

During routine maintenance of the four BAM-class offshore patrol vessels (Meteoro, Rayo, Relámpago, Tornado), **fatigue cracks were discovered** in the open-air clad bimetallic transition plates connecting the aluminium superstructure to the steel hull. Key findings:

- Cracks consistently located at the steel-aluminium interface boundary of the bimetallic plate, exactly where oxide inclusions act as nucleation sites.
- Crack lengths of 135 to 200 cm, with gap widths of 0.9 to over 3 mm. On the Relámpago, air conditioning air was detectable escaping through the cracks in the mast.
- Cracks originated at structural corners, the highest stress concentration points under hull bending moments. The investigation confirmed these locations correspond to the master frame, one of the structurally most demanding positions on the vessel.
- All four vessels affected. Three vessels showed through-cracks in the guardacalores (funnel casing); one vessel showed through-cracks in the mast bimetallic plate as well.
- The report explicitly concluded: "es de esperar que estas grietas se sigan propagando" (these cracks are expected to continue propagating).

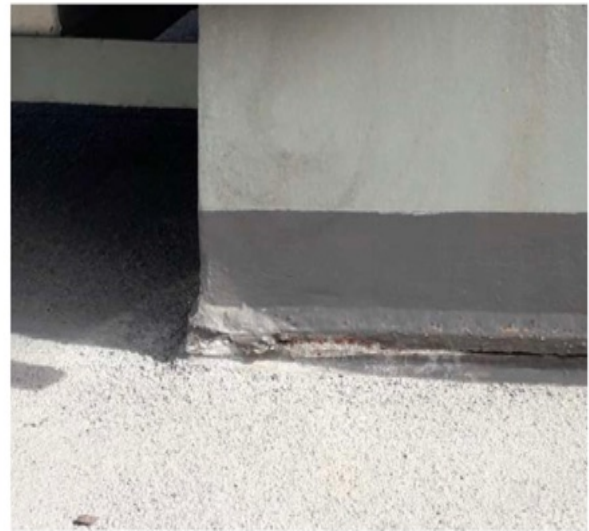
Figure 9. Crack in the startboard-side (Er) heat shield of the Rayo

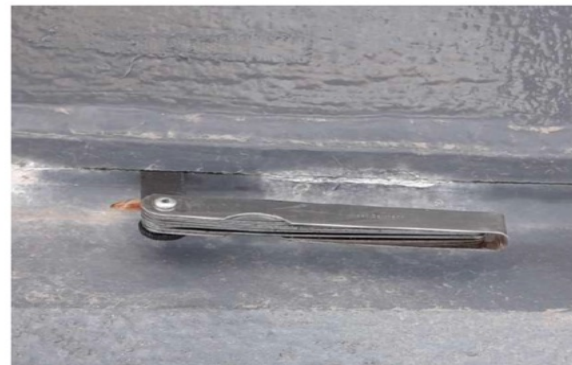
Figure 11. Continuation of the crack at the port-side (Br) bow corner of the Rayo's mast, with a 0.9 mm feeler gauge inserted

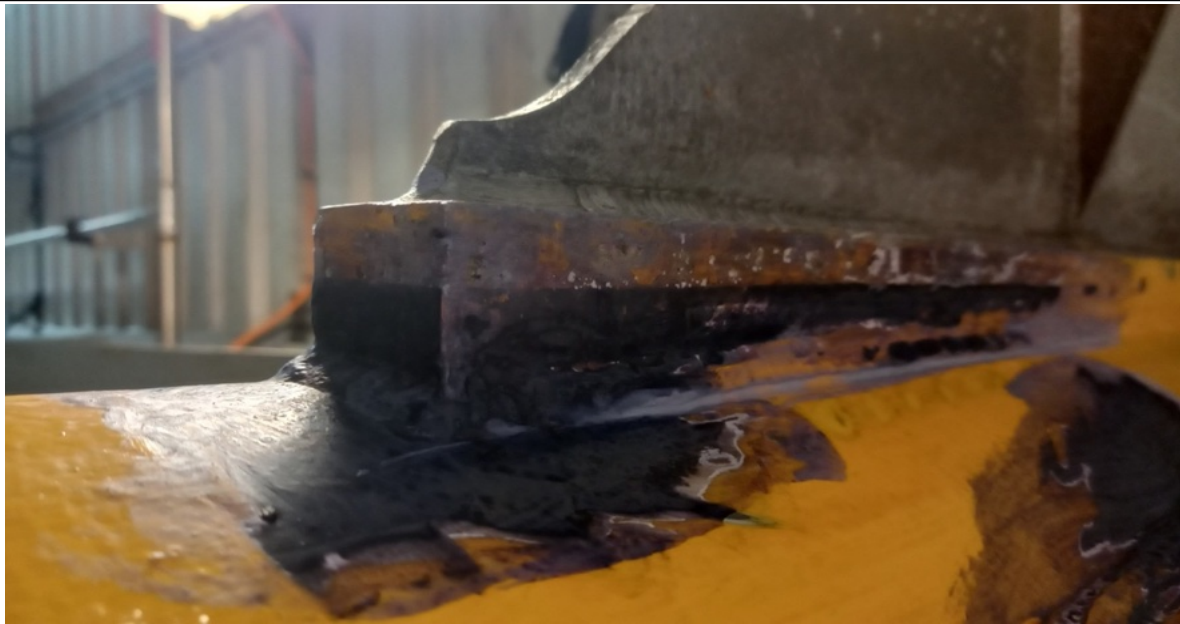
Figure 12. Unscheduled repainting job with Open-Air Transition-Joints (Condor)

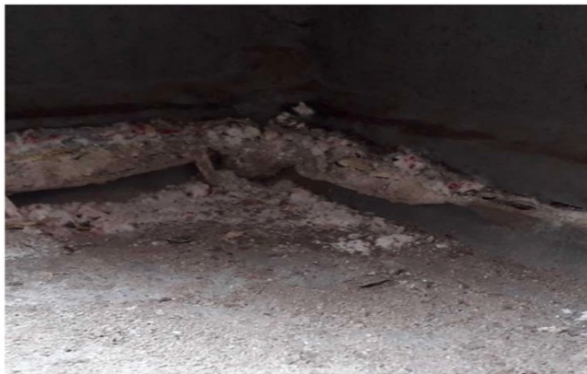
Figure 13. Crack in the port-side (Br) heat shield of the Meteoro

- Immediate investigation by specialist hull engineers, dry-dock inspection across all four vessels.
- Temporary repair by epoxy filling (Hempel Epoxi filler) to seal through-cracks up to 200 cm long and 3 mm wide, not a structural repair, only a temporary seal.
- Structural repair at next scheduled dry-dock: removal and replacement of the cracked bimetallic plates. For cracks 135–200 cm long in structural positions at the master frame, this is a significant shipyard operation involving cutting, fit-up, welding, NDT, and repainting.
- Operational impact: vessels affected while in service (the Relámpago had air conditioning air escaping through cracks in the mast, indicating compromise of a pressure-separated space).

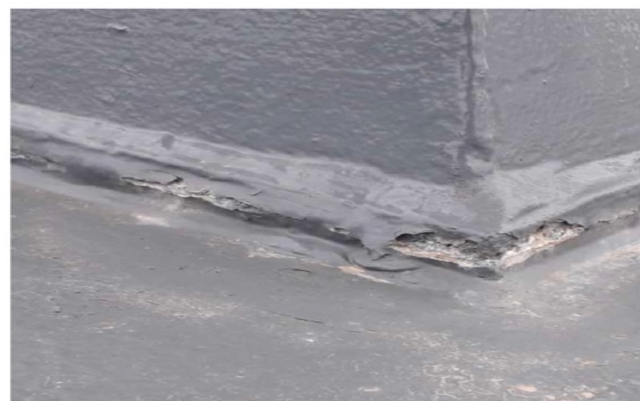
Figure 14. Corner of the Meteoro's mast

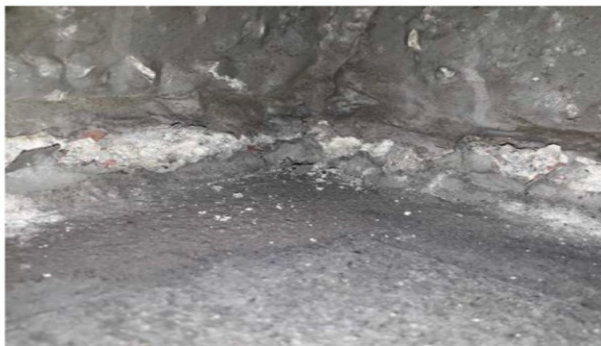
Figure 15. Corner of the port-side (Br) heat shield of the Relámpago
